# Management Plan

For the Protection of the Site of Lunca

Impact Case Study

# Management Plan for the Protection of the Site of Iunca

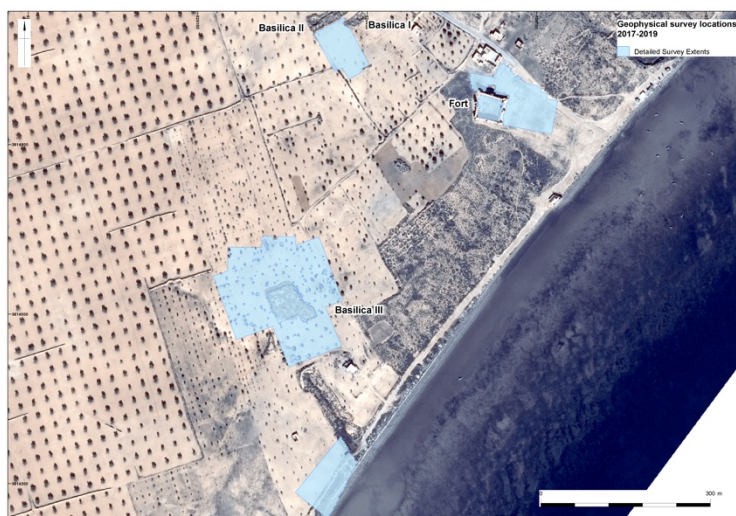
4.1.4 Following the remote sensing and field-walking, targeted geophysical survey training (Voke 2019a, 2019b, 2017a, 2017b) was carried out at several locations through the site at Iunca (Figure 4).

**Figure 4:** Location of geophysical surveys 2017 - 2019

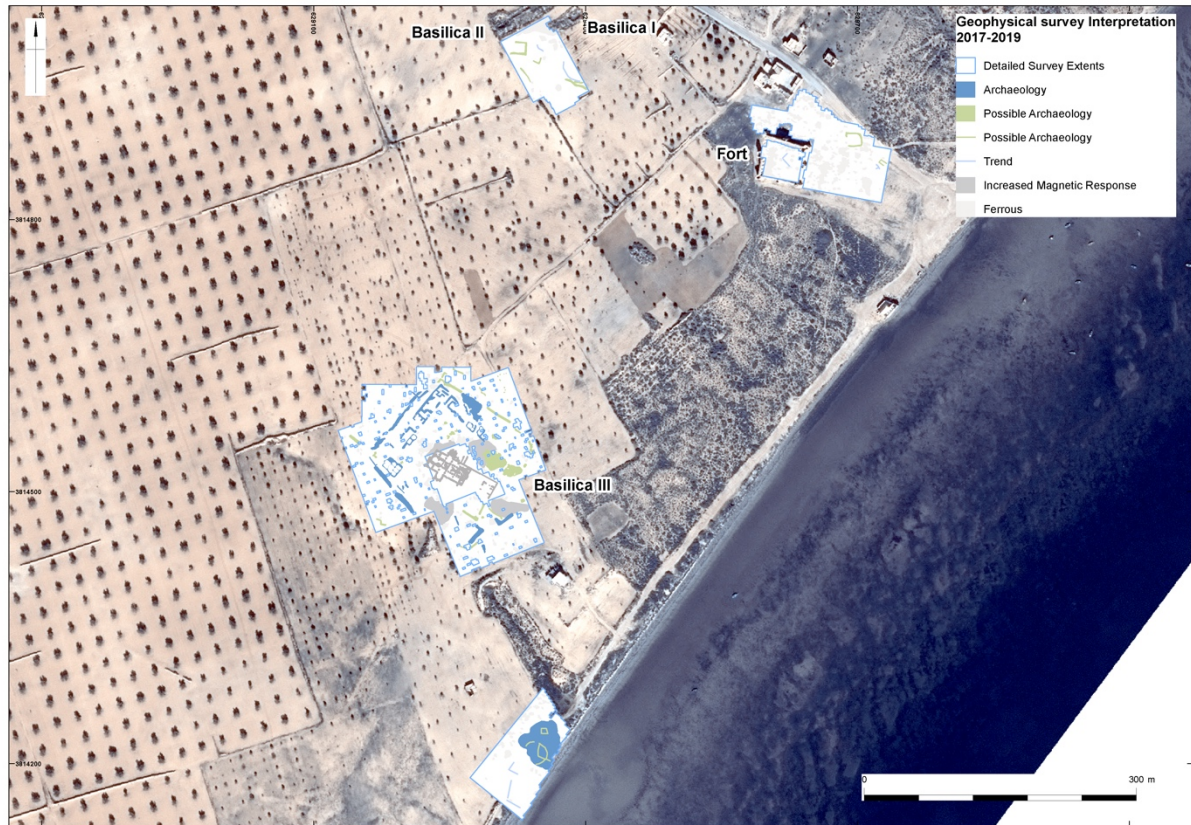
4.1.5 These sites were targeted around previously known archaeological monuments of the three basilicas, the inside and an area north and east of the fort. An additional area east of basilica III was also surveyed following data collected from fieldwalking. In total an area of 5.8 ha of gradiometer survey was achieved across the four survey areas. The gradiometer surveys were successful in identifying previously unknown subsurface archaeological features in all the survey areas (**Figure 5**).

**Figure 5:** Location of geophysical; surveys and interpretation 2017 - 2019

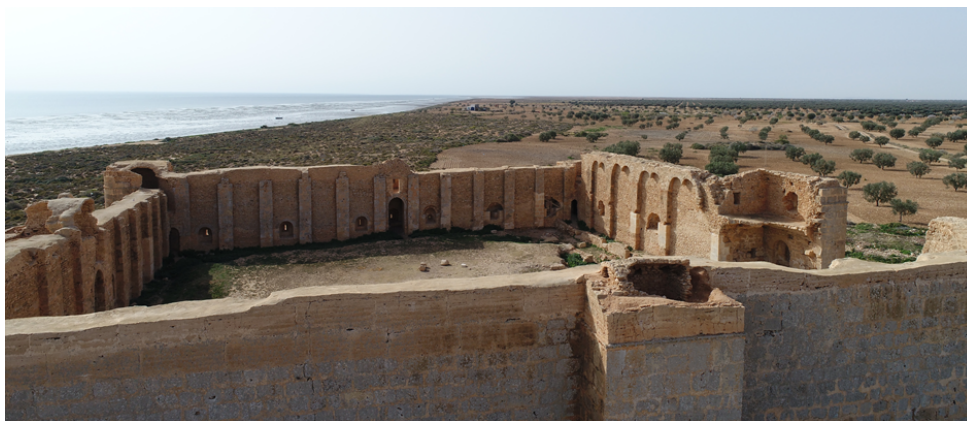
4.3.4 Amongst all of these activities, the reconstruction of the lower part of the southern external wall with new stones is the most worrying recent intrusion. The condition assessment has identified that this modification is further compromising the integrity and stability of the structure. The stones used for the restoration are soft limestone, which is heavily damaged by wind and salinity coming from the adjacent sea (for the analysis we thank Lisa Mol). Moreover, in a later medieval period, after a phase of abandonment of the fort, this was reused, and its southern and eastern walls were then elevated through the reconstruction of the upper parts of the walls with a mud structure. These upper parts were also consolidated in the 1980s with white mortar laid out on the top of them (**Figure 10**).

**Figure 10:** Restoration of the top of the mud-walls with white mortar

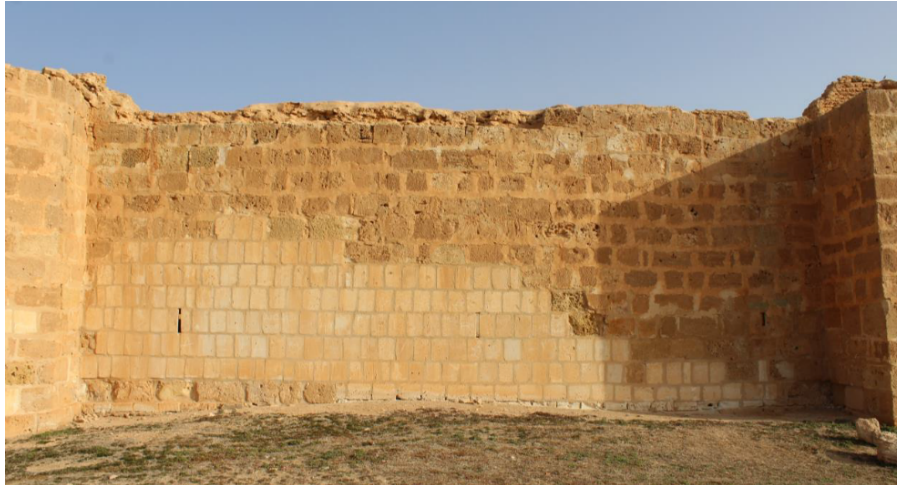
4.3.5 This intervention has caused the collapse of the former in the south façade, since the mortar is much heavier than mud and reacts in a different way to natural events. This is clearly visible in the external south wall (**Figure 11**).

**Figure 11:** Restoration of the curtain walls of the fort – southern external part of the wall

- 6.3.19 The monument currently presents several problems of stability and requires a substantial intervention of restoration. It is recommended that small interventions in the most damaged parts of the monument are limited. Instead in order to protect the monument in the long-term, it is necessary to gather a group of expert conservators, substantial funds and proceed with a systematic, well planned restoration of the monument, to guarantee its security. Among others aspects, this future intervention should take into account the historical sequence, with the aim of preserving the stratigraphic limits and thereby the history of the building; the diversity of materials employed (limestone, mud walls), which require different treatments and demand compatible materials; and the geographical situation of the place, close to the coast and therefore exposed to strong natural erosion.

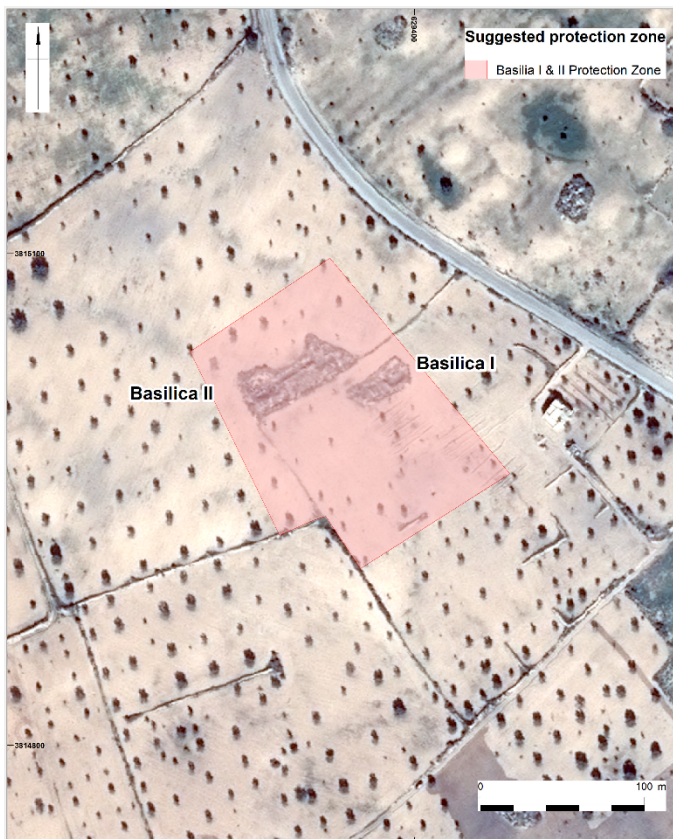
6.3.3 *Conditions:* The two churches, excavated in 1920s, are in a very bad state of preservation. The excavations did not entirely expose the monuments. Only an approximate plan of the monuments was created during this period of excavation. During the excavation the spoil heaps were accumulated around the monuments and left there. Over the years the spoil heaps have collapsed and have covered almost the entirety of the buildings. As a result, the excavated remains are much lower than the level of the present-day surface.

**Figure 14:** Location of the protection zone for Basilica I & II based upon geophysical results

6.3.4 Uncover the buildings again and proceed with restoration would require very high costs, beside not knowing the current state of preservation of the monument, uncovering may incur the collapse of the complex. Therefore, it is recommended that the visible structures are studied and mapped and a condition assessment of the monument is carried out. The structural remains should be located with accurate co-ordinates and reburied to assure long term protection (on reburial of ancient monuments and its practice see Demas 2004). It is highly recommended that the area where the two structures are located is fenced, and clearly demarcated (**Figure 14**). This would allow for continued control of the area and the protection of this sector from tree planting and cultivation.

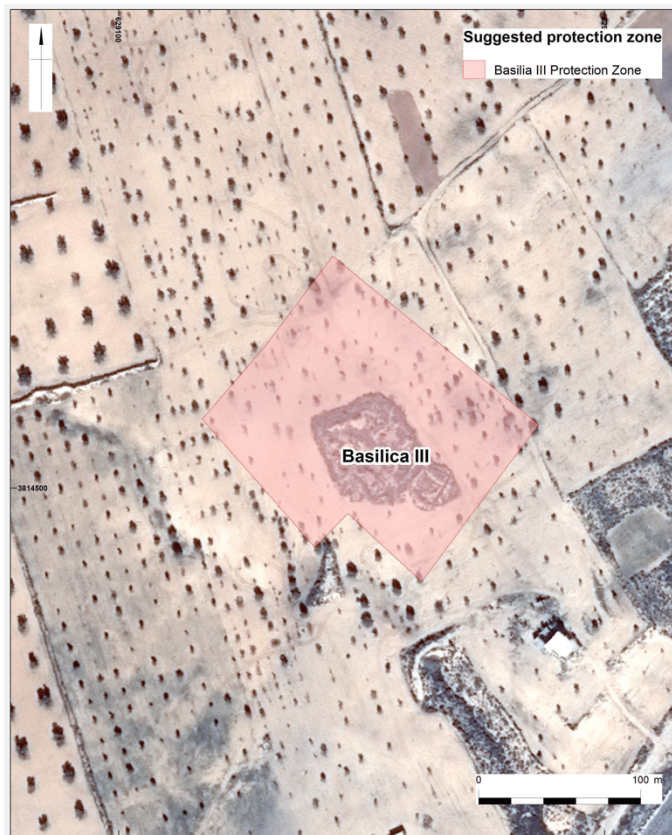
**Figure 16:** Location of protection zone for Basilica III based upon geophysical survey results

- 6.3.9 Archaeologists will need to carry out every year an assessment of the condition of the walls, and, if any issue is identified, a restoration will need to be planned and conducted immediately.
- 6.3.10 Create an explanatory board with information for the tourists and maintain the area of the fence that surrounds the church is another essential element, in order to provide constant protection for the structural remains.
- 6.3.11 Given that the geophysical survey identified a much larger area of subsurface archaeological remains surrounding the church protection zone should be extended to correspond with these results and no further cultivation should be allowed in this area in the future (**Figure 16**).
